REPORT No. 55/BT/2019

Subject:	Testing the IP 68 ingress protection rating of water meter housing Ultrimis
Ordered:	Aparator Powogaz S.A., ul. Klemensa Janickiego 23/25, 60-542 Poznań, Poland
Project No.:	UP/BT-25109/OR
The date of the report:	30.04.2019
The date and place of test::	26-30.04.2019, the research hall C in KOMAG Institute of Mining Technology at Pszczyńska 37 in Gliwice, Poland

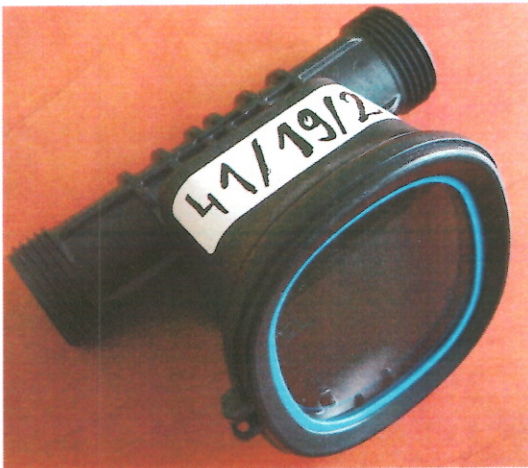
Fig. 1. Water meter housing Ultrimis

Water meter housing Ultrimis with a serial number PPC 0008585 was tested for the first characteristic numeral IP 6X (Fig. 1). Water meter housing Ultrimis with a serial number PPC 0008562 was tested for the second characteristic numeral IP X8 (Fig. 2). In the Laboratory, they have been consecutively marked with sample numbers: 41/19/2 and 41/19/1, according to the R-BT/9 procedure.

Dust did not get inside the tested water meter housing.

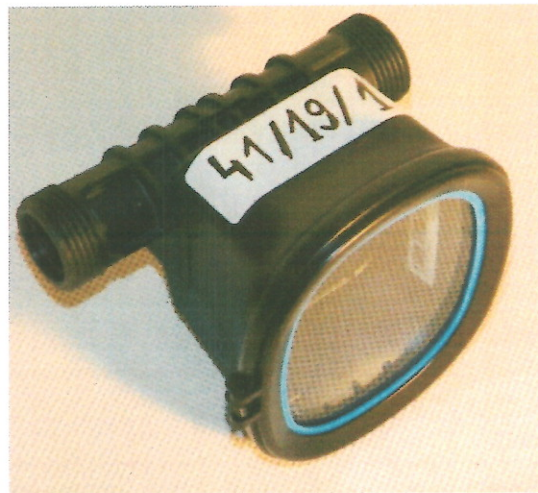
Fig. 2. Water meter housing Ultrimis

The Orderer defined the depth of immersion of housing to 1,2 m below the water surface. The test was carried out for 24 hours. Water did not get inside the tested water meter housing.
